**Flood Control Project Maintenance  
Levee Inspections**

**Fall 2011 Levee Maintenance Deficiency Summary Report**

**Brannan Andrus Levee Maintenance District**

**Levee Inspection Report By Mile - Fall 2011**

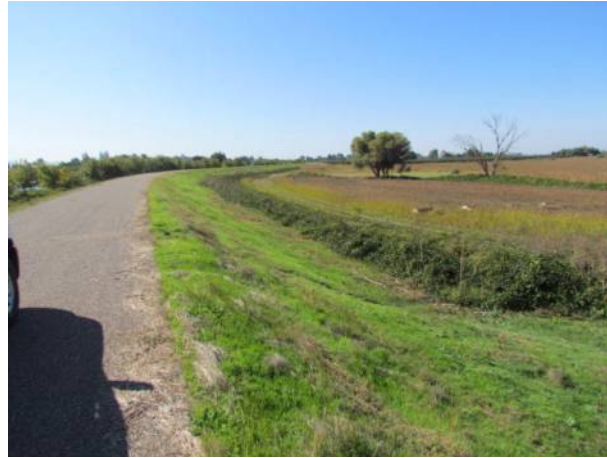
Levee Mile Report Line	1
Start Levee Mile	0.50
End Levee Mile	0.75
Location	Land Side
Category	Earthen Levee
Item	Vegetation
Looking southwest at wild roses or berryvines on landside toe.	
richard_f_20111020_317.jpg

LMR No.	Levee Mile		Category	Item	* Location	** Rating	Action/Comment	GPS Latitude/Longitude		Issue No. Photo
	Start	End						Start	End	
1	0.50	0.75	Earthen Levee	Vegetation	LS	M	Remove the wild growth other than native grasses from the levee slopes. Inspector Comments: Wild roses or berryvines at landside toe.	38.182702 ° -121.570497 °	38.182198 ° -121.574877 °	1 Y
2	2.25	2.25	Earthen Levee	Trim / Thin Trees	LS	W	Trim trees to at least five feet above ground level.	38.163460 ° -121.584406 °	38.163460 ° -121.584406 °	6
3	2.29	2.34	Earthen Levee	Encroachments	LS	CO	Landscaping	38.162918 ° -121.584721 °	38.162322 ° -121.585081 °	36 Y
4	2.30	2.30	Earthen Levee	Encroachments	WS	M	Firewood	38.162773 ° -121.584767 °	38.162773 ° -121.584767 °	3 Y
5	2.36	2.36	Earthen Levee	Animal Control	LS	M	No rodents visible, but rodent burrows visible; need to backfill and compact or grout burrows.	38.162004 ° -121.585229 °	38.162004 ° -121.585229 °	7

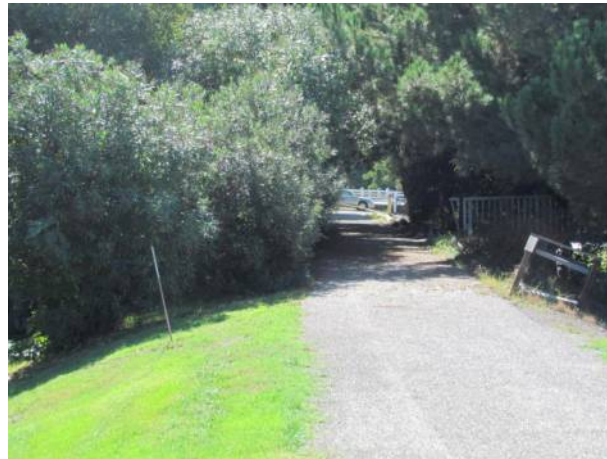
Levee Mile Report Line	3
Start Levee Mile	2.29
End Levee Mile	2.34
Location	Land Side
Category	Earthen Levee
Item	Encroachments
Looking south at dense landscape on waterside and landside of levee.	
richard_f_20111020_318.jpg

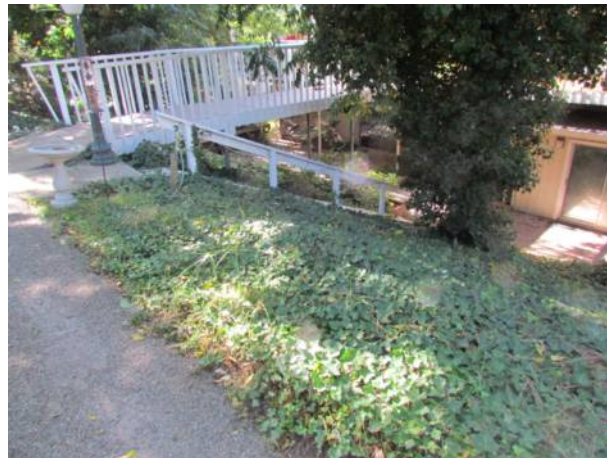
Levee Mile Report Line	3
Start Levee Mile	2.29
End Levee Mile	2.34
Location	Land Side
Category	Earthen Levee
Item	Encroachments
Looking west at ground cover on landside slope.	
richard_f_20111020_319.jpg

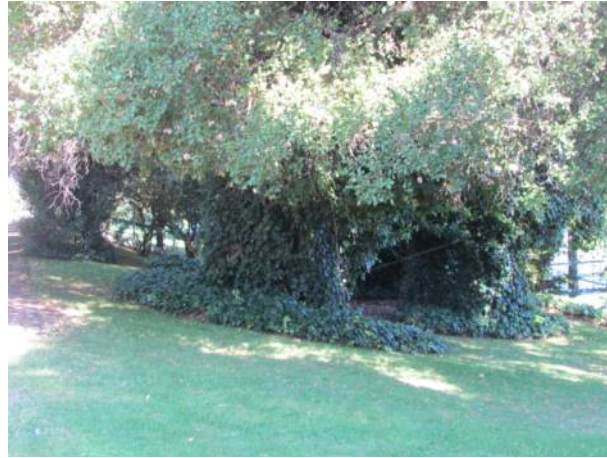
Levee Mile Report Line	3
Start Levee Mile	2.29
End Levee Mile	2.34
Location	Land Side
Category	Earthen Levee
Item	Encroachments
Looking north at dense vegetation on waterside slope.	
richard_f_20111020_320.jpg

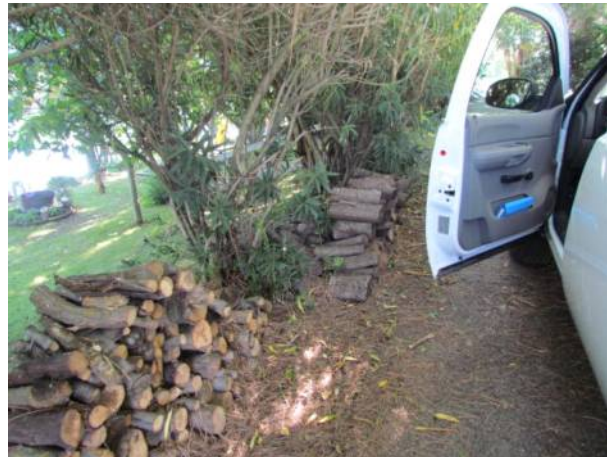
Levee Mile Report Line	4
Start Levee Mile	2.30
End Levee Mile	2.30
Location	Water Side
Category	Earthen Levee
Item	Encroachments
Looking east at firewood on waterside shoulder.	
richard_f_20111020_321.jpg

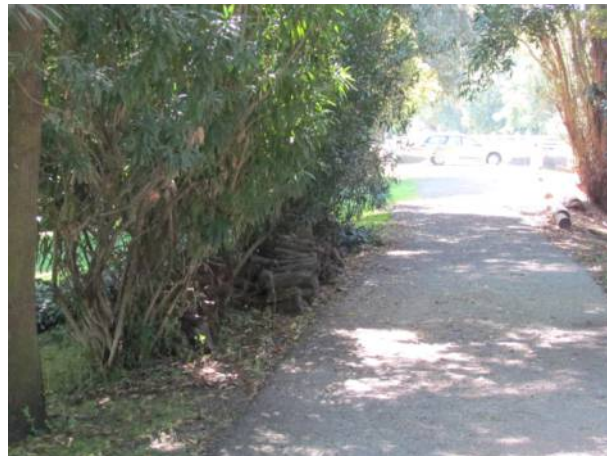
Levee Mile Report Line	4
Start Levee Mile	2.30
End Levee Mile	2.30
Location	Water Side
Category	Earthen Levee
Item	Encroachments
Looking south at firewood on waterside shoulder.	
richard_f_20111020_322.jpg

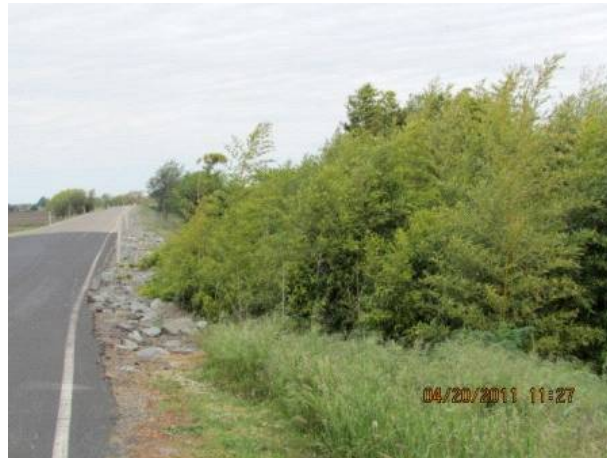
Levee Mile Report Line	9
Start Levee Mile	3.93
End Levee Mile	3.93
Location	Water Side
Category	Earthen Levee
Item	Vegetation

Looking west at dense vegetation on waterside slope.

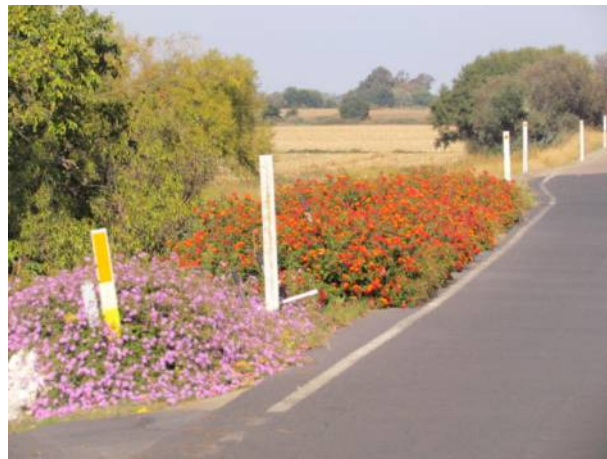
Levee Mile Report Line	10
Start Levee Mile	3.93
End Levee Mile	3.97
Location	Land Side
Category	Earthen Levee
Item	Encroachments

Looking northeast at landscape on landside slope.

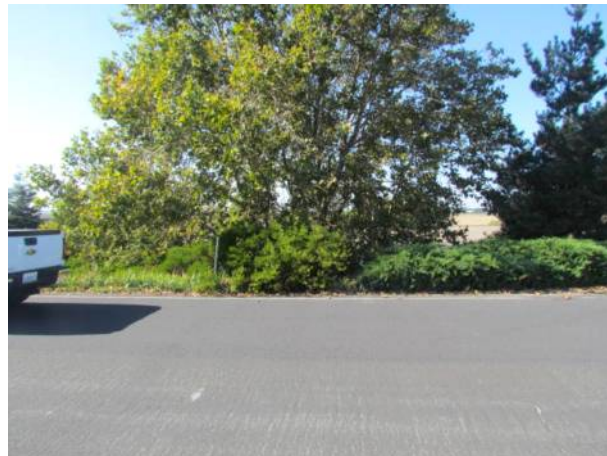
Levee Mile Report Line	10
Start Levee Mile	3.93
End Levee Mile	3.97
Location	Land Side
Category	Earthen Levee
Item	Encroachments

Looking west at dense landscape on landside slope.

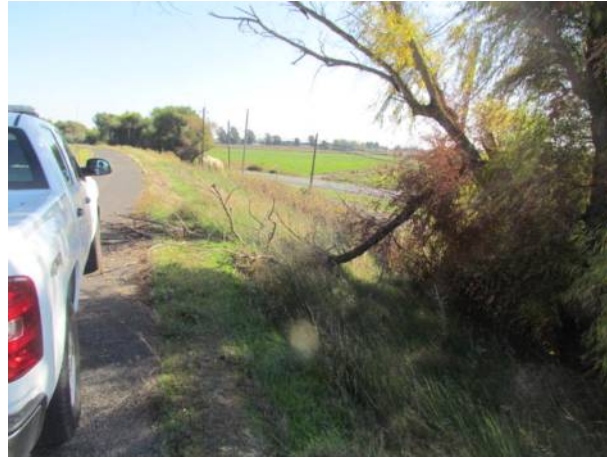
Levee Mile Report Line	19
Start Levee Mile	5.42
End Levee Mile	5.42
Location	Land Side
Category	Earthen Levee
Item	Encroachments

Looking southwest downed tree limb on landside slope.

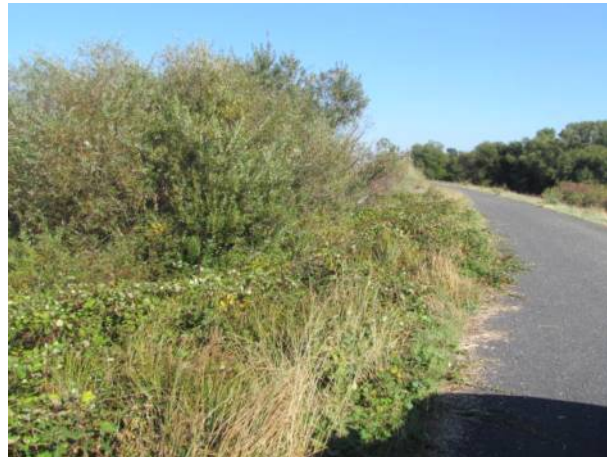
Levee Mile Report Line	20
Start Levee Mile	5.63
End Levee Mile	5.67
Location	Water Side
Category	Earthen Levee
Item	Vegetation

Looking south at dense vegetation on waterside slope.

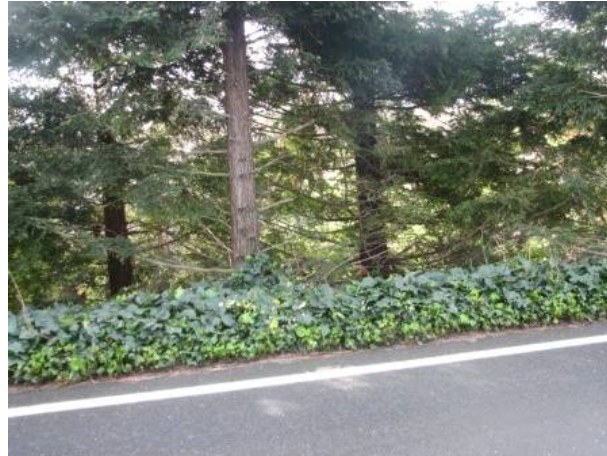
Levee Mile Report Line	4
Start Levee Mile	0.81
End Levee Mile	0.83
Location	Land Side
Category	Earthen Levee
Item	Encroachments
Landscaping on landside slope blocking view of slope from LM .81 to 0.83	
richard_f_20111014_304.jpg

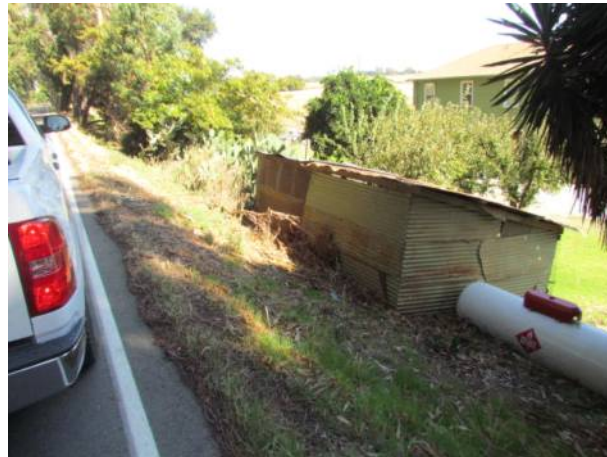
Levee Mile Report Line	9
Start Levee Mile	1.83
End Levee Mile	1.83
Location	Land Side
Category	Earthen Levee
Item	Encroachments
Looking northeast tool shed on landside toe.	
richard_f_20111020_316.jpg

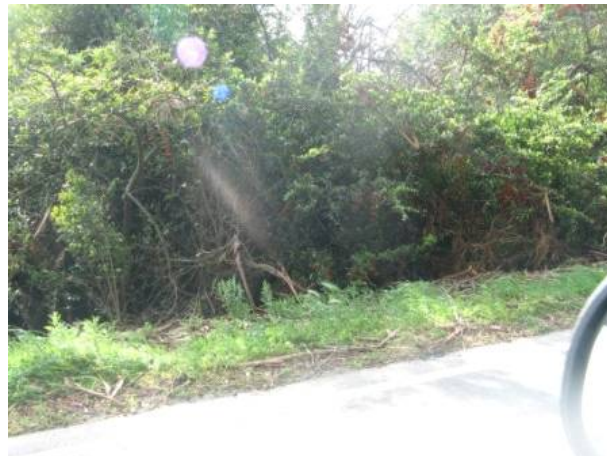
Levee Mile Report Line	11
Start Levee Mile	1.91
End Levee Mile	1.95
Location	Land Side
Category	Earthen Levee
Item	Encroachments
Landscaping on landside slope blocking view of slope from LM 1.91 to 1.95	
richard_f_20111014_305.jpg

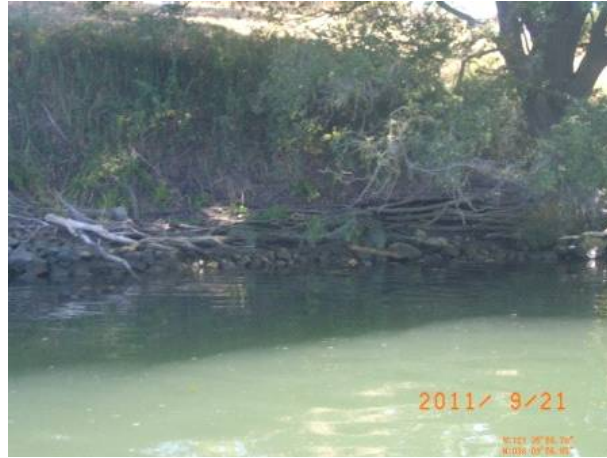
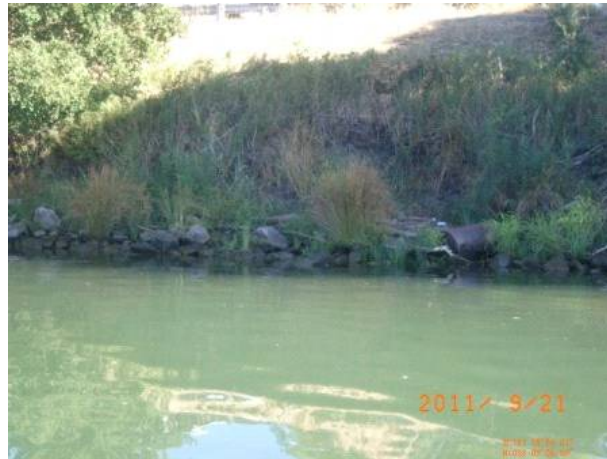
Levee Mile Report Line	14
Start Levee Mile	2.53
End Levee Mile	2.63
Location	Water Side
Category	Supplemental
Item	USACE Erosion Survey

14	2.53	2.63	Supplemental	USACE Erosion Survey	WS	M	Inspector Comments: 2009 - Short reach of vertical bank at the toe. 2010 - Large tree is getting ready to fall in. 2011: No observed change. [2011 Site ID: SAC_18-1_L]	38.165945 ° -121.599345 °	38.165498 ° -121.600080 °	17 Y
15	2.66	2.74	Supplemental	USACE Erosion Survey	WS	M	Inspector Comments: 2009 - Large scallop from rotational failure. One fallen tree and one large tree with half of its root structure exposed. 2011: No observed change. [2011 Site ID: SAC_18-0_L]	38.165303 ° -121.600477 °	38.164682 ° -121.601804 °	18 Y
16	2.93	3.13	Earthen Levee	Encroachments	LS	PO	Urban	38.163317 ° -121.604813 °	38.162707 ° -121.608262 °	30

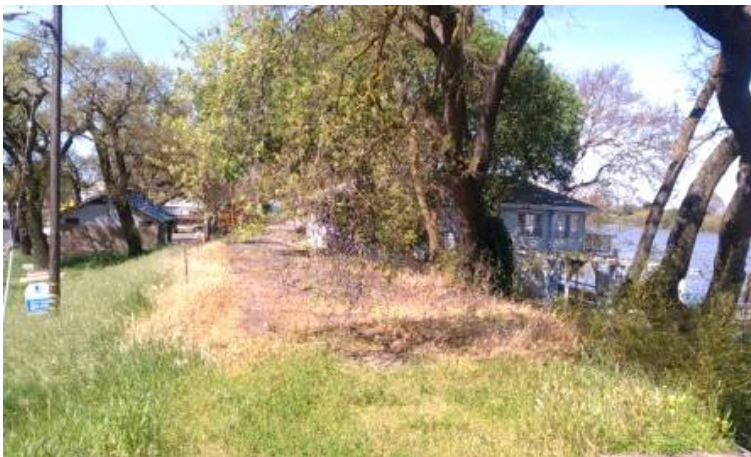
Levee Mile Report Line	17
Start Levee Mile	3.17
End Levee Mile	3.17
Location	Water Side
Category	Earthen Levee
Item	Trim / Thin Trees

Looking south at overhanging tree on waterside shoulder.

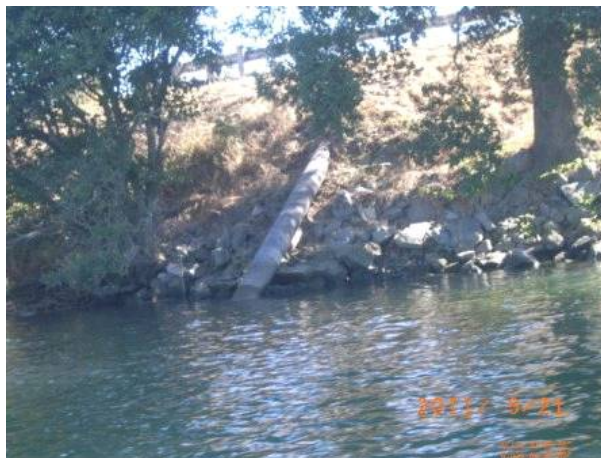
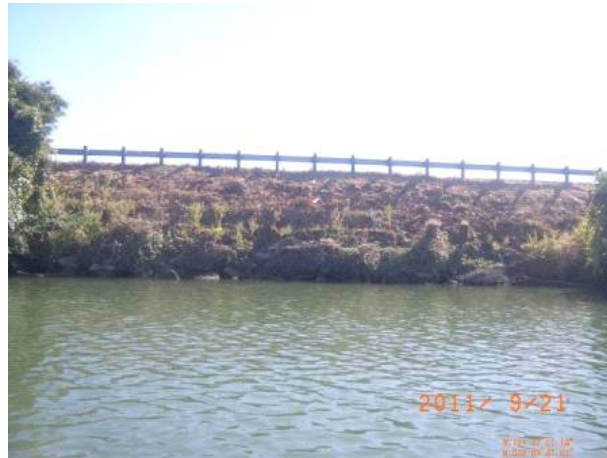
Levee Mile Report Line	22
Start Levee Mile	3.62
End Levee Mile	3.70
Location	Water Side
Category	Supplemental
Item	USACE Erosion Survey

21	3.53	3.60	Earthen Levee	Trim / Thin Trees	LS	M	Trim trees to at least five feet above ground level.	38.162590 ° -121.615345 °	38.162728 ° -121.616622 °	22
22	3.62	3.70	Supplemental	USACE Erosion Survey	WS	U	Inspector Comments: 2008 - Overstepped levee section with pocket erosion. Plans for repair currently in the design phase. 2010 - Very steep slope with slumps, longitudinal cracking, and overturned trees. 2011: Upgraded to CRITICAL. Sections of vertical slope with highway on top. Heavy vegetation in front of most of the erosion pockets. [2011 Site ID: SAC_16-8_L]	38.162959 ° -121.617323 °	38.163334 ° -121.619312 °	20 Y
23	4.01	4.01	Earthen Levee	Trim / Thin Trees	LS	M	Trim trees to at least five feet above ground level.	38.164470 ° -121.624012 °	38.164470 ° -121.624012 °	31
24	4.04	4.15	Earthen Levee	Encroachments	LS	CO	Landscaping	38.164498 ° -121.624343 °	38.165167 ° -121.626273 °	59
25	4.47	4.47	Earthen Levee	Trim / Thin Trees	LS	M	Trim trees to at least five feet above ground level.	38.167135 ° -121.631662 °	38.167135 ° -121.631662 °	32

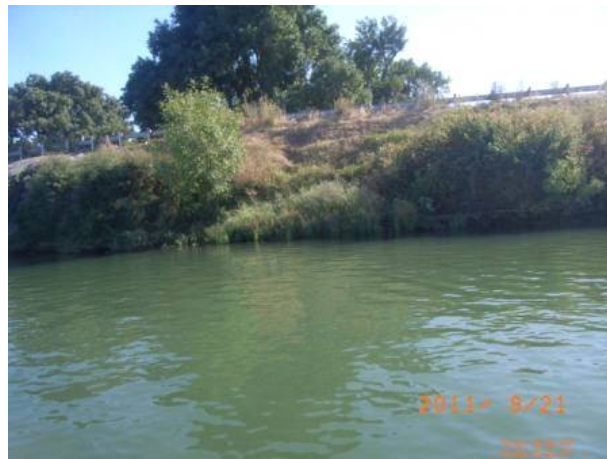
Levee Mile Report Line	29
Start Levee Mile	5.68
End Levee Mile	5.71
Location	Water Side
Category	Supplemental
Item	USACE Erosion Survey

LMR No.	Levee Mile		Category	Item	Location *	Rating **	Action/Comment	GPS Latitude/Longitude		Issue No. Photo
	Start	End						Start	End	
29	5.68	5.71	Supplemental	USACE Erosion Survey	WS	M	Inspector Comments: 2009 - Tension cracks on road on top of levee. Erosion into the levee slope with large mass failure scallop. 2010 - Site extended further upstream to account for additional erosion. Very steep slope with slumping. 2011: No observed change. [2011 Site ID: SAC_15-0_L]	38.172580 ° -121.651821 °	38.172733 ° -121.652499 °	21 Y
30	5.68	5.71	Earthen Levee	Trim / Thin Trees	LS	M	Trim trees to at least five feet above ground level.	38.172388 ° -121.651892 °	38.172512 ° -121.652322 °	36
31	5.82	6.15	Earthen Levee	Vegetation	LS	W	Remove the wild growth other than native grasses from the levee slopes.	38.173130 ° -121.654285 °	38.174559 ° -121.659867 °	13
32	6.35	6.38	Earthen Levee	Trim / Thin Trees	LS	M	Trim trees to at least five feet above ground level.	38.173586 ° -121.663297 °	38.173391 ° -121.663786 °	14

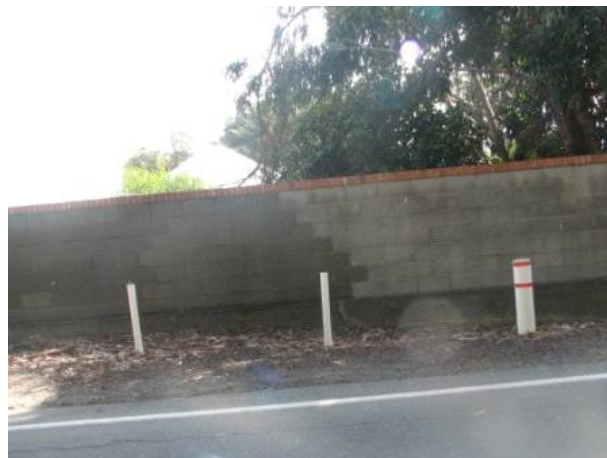
Levee Mile Report Line	33
Start Levee Mile	6.82
End Levee Mile	6.82
Location	Land Side
Category	Earthen Levee
Item	Encroachments

33	6.82	6.82	Earthen Levee	Encroachments	LS	CO	Fences	38.169008 ° -121.669420 °	38.169008 ° -121.669420 °	42 Y
34	7.00	7.05	Supplemental	USACE Erosion Survey	WS	M	Inspector Comments: 2011: Large section of bank slumped off. [2011 Site ID: SAC_13-6_L]	38.166583 ° -121.670684 °	38.165794 ° -121.671014 °	23 Y
35	7.66	7.66	Earthen Levee	Encroachments	LS	M	Prunings	38.157055 ° -121.675445 °	38.157055 ° -121.675445 °	24 Y
36	8.07	8.44	Supplemental	USACE Erosion Survey	WS	M	Inspector Comments: 2010 - Small inlet area behind a man-built spit. Bank is slumping and could possibly be fixed with maintenance. 2011: Site continues to worsen. [2011 Site ID: SAC_12-1_L]	38.151867 ° -121.682201 °	38.148711 ° -121.682790 °	37 Y
37	8.35	8.71	Earthen Levee	Trim / Thin Trees	LS	M	Trim trees to at least five feet above ground level.	38.150112 ° -121.682305 °	38.144977 ° -121.683345 °	44 Y
38	8.46	8.46	Earthen Levee	Encroachments	WS	M	Tree or limb	38.148323 ° -121.682548 °	38.148323 ° -121.682548 °	33

Brick wall on landside shoulder at LM 6.82

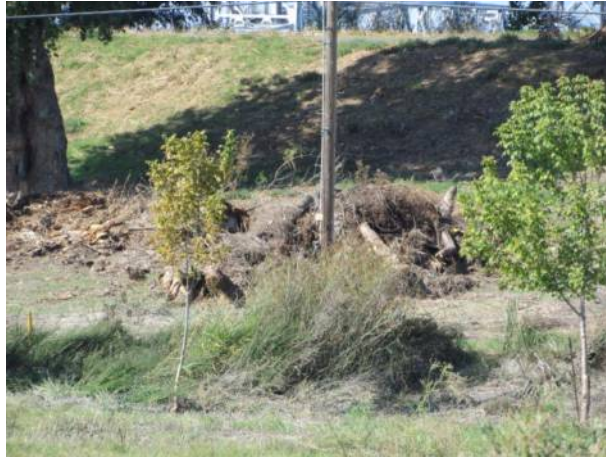
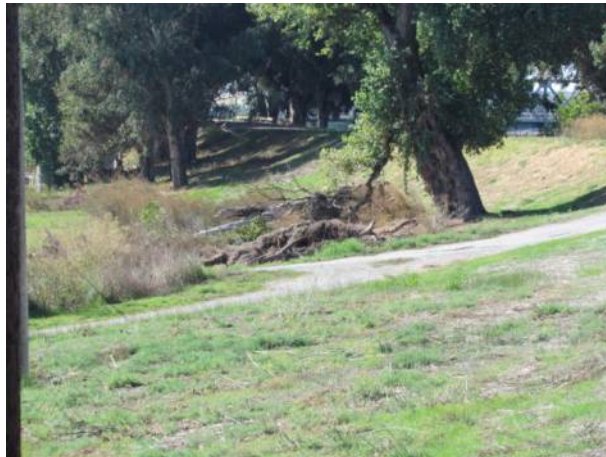
Levee Mile Report Line	35
Start Levee Mile	7.66
End Levee Mile	7.66
Location	Land Side
Category	Earthen Levee
Item	Encroachments

Looking west at prunings on landside toe.

Looking south at prunings on landside toe.

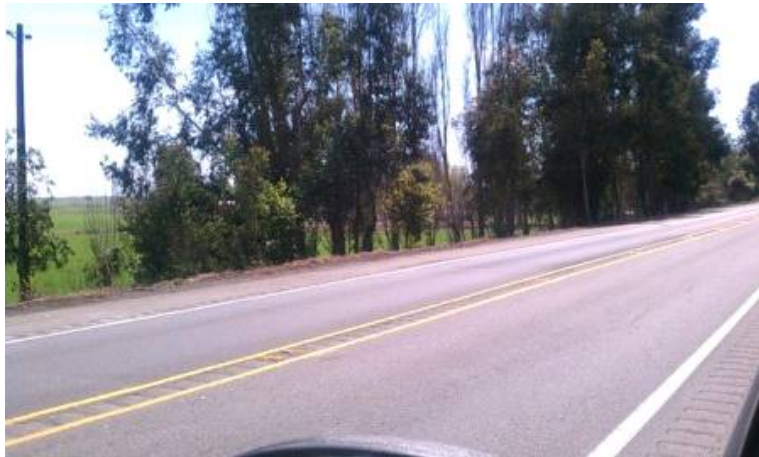
Levee Mile Report Line	37
Start Levee Mile	8.35
End Levee Mile	8.71
Location	Land Side
Category	Earthen Levee
Item	Trim / Thin Trees

Looking southeast at trees on landside shoulder and slope.

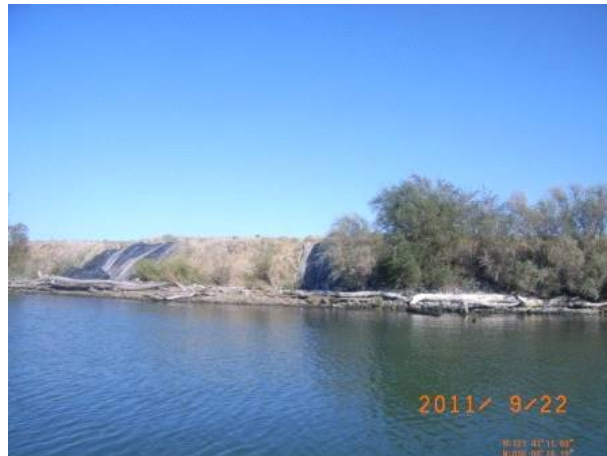
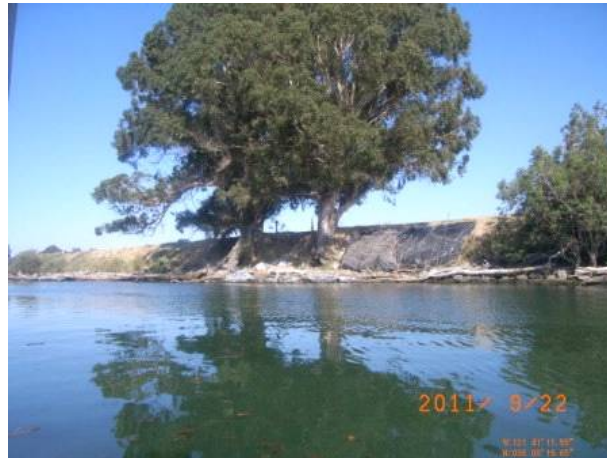
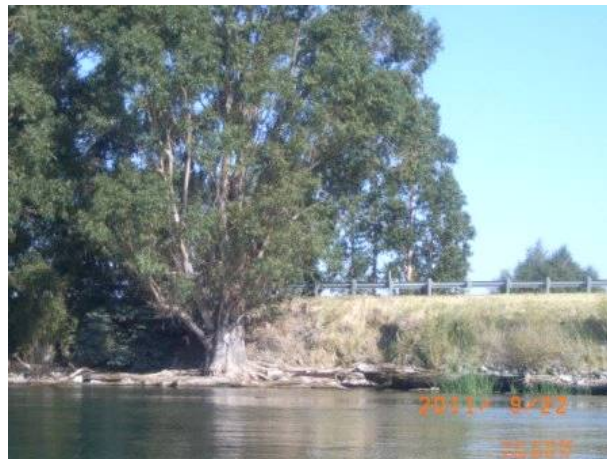
Levee Mile Report Line	39
Start Levee Mile	8.94
End Levee Mile	9.17
Location	Water Side
Category	Supplemental
Item	USACE Erosion Survey

39	8.94	9.17	Supplemental	USACE Erosion Survey	WS	M	Inspector Comments: 2008 - Erosion causing vertical bank at the highway on top of levee. The whole bank along the highway should be repaired. 2009 - Minimal new erosion. 2011: Bank continues to slowly erode. [2011 Site ID: SAC_11-2_L]	38.141399 ° -121.685346 °	38.138158 ° -121.686531 °	38 Y
40	9.42	9.42	Earthen Levee	Trim / Thin Trees	WS	W	Trim trees to at least five feet above ground level.	38.135106 ° -121.686065 °	38.135106 ° -121.686065 °	15
41	9.68	9.74	Earthen Levee	Vegetation	WS	M	Remove the wild growth other than native grasses from the levee slopes.	38.131448 ° -121.686432 °	38.130537 ° -121.686737 °	16

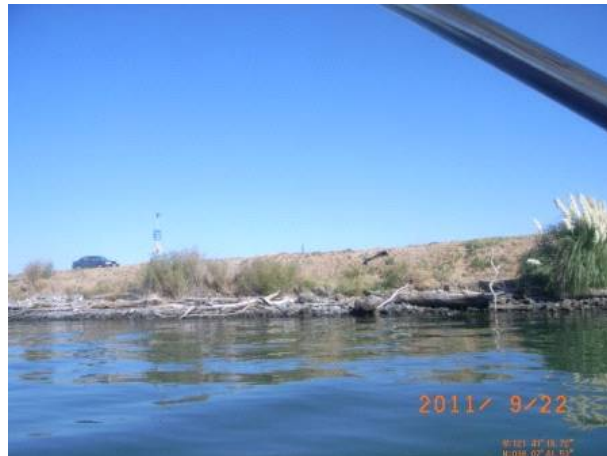
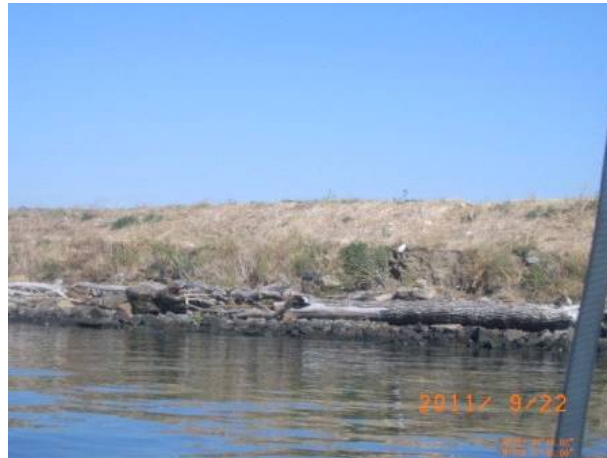
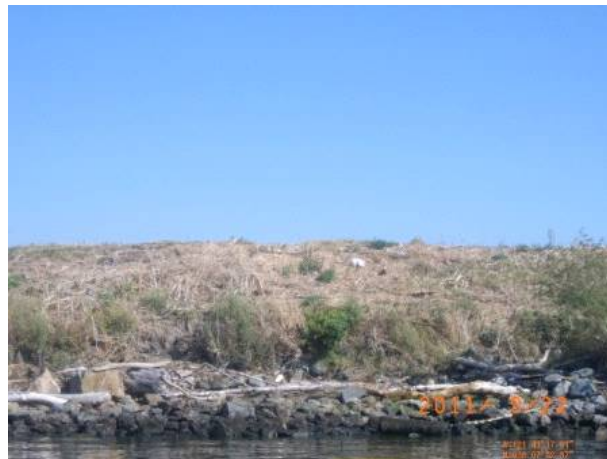
Levee Mile Report Line	42
Start Levee Mile	9.72
End Levee Mile	9.94
Location	Water Side
Category	Supplemental
Item	USACE Erosion Survey

42	9.72	9.94	Supplemental	USACE Erosion Survey	WS	M	Inspector Comments: 2004 - Wave wash pockets approximately 100 ft long with new full bank rock between the pockets. 2005 - Spot repairs, but toe is still eroding in several places. 2006 - Low vertical bank along roadway. 2007 - A PL 84-99 repair was constructed, it cover the majority of the site with the exception of the upstream 150 to 200 ft and the downstream 250 ft, therefore it is being kept in the inventory. 2009 - Minimal new erosion. 2010 - Outboard berm looks good, but the banks are still very steep. 2011: While the outboard berm is protecting against wavewash, bank still has slumping issues. [2011 Site ID: SAC_10-8_L]	38.129722 ° -121.687468 °	38.127672 ° -121.688646 °	39 Y
----	------	------	--------------	----------------------	----	---	---	------------------------------	------------------------------	---------
